Architectural Detail

Lining Repair

STONHARD
1000 East Park Avenue

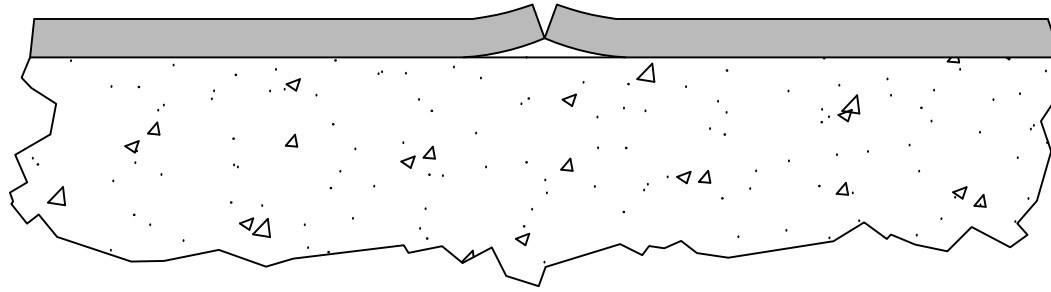
Figure 1

Damaged Lining

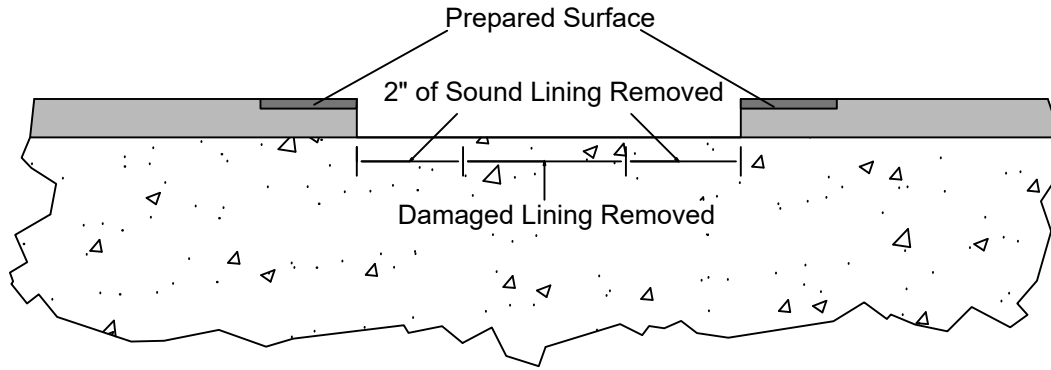
Figure 2

Prepared Surface

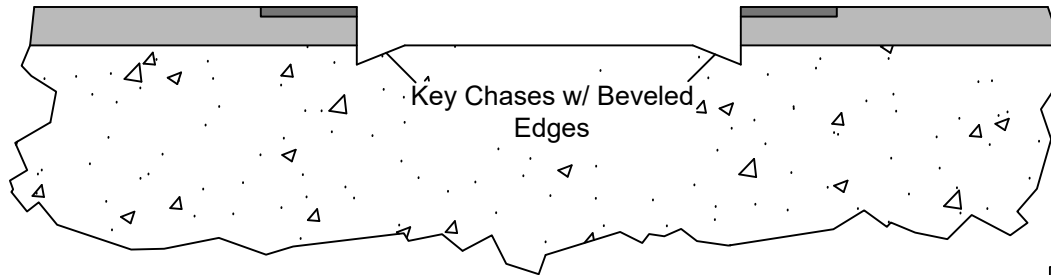
Figure 3

Key Chases w/ Beveled Edges
